September 11, 2023

# REPORT OF BINATIONAL JOINT SURVEY OF AUGUST 30, 2023, OF THE BUOYS INSTALLED WITHIN THE RIO GRANDE NEAR EAGLE PASS/PIEDRAS NEGRAS

# Maverick County, Texas

INTERNATIONAL BOUNDARY & WATER COMMISSION
United States Section
El Paso, Texas

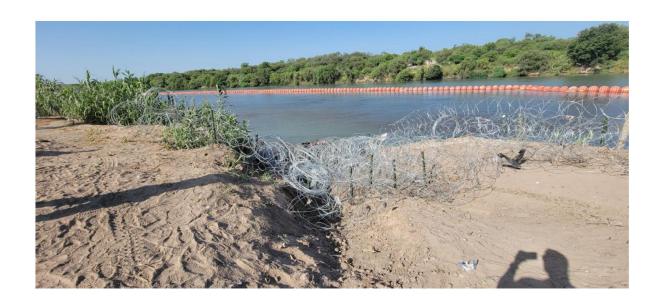
**Exhibit 2: View of the Eagle Pass Buoys**

The State of Texas installed a buoy barrier in the Eagle Pass/Piedras Negras reach of the Rio Grande in early July (Exhibit 1, Exhibit 2). The location of the buoys is approximately 2 miles (3.2 kilometers) downstream of the Camino Real International Bridge, in the vicinity of 28° 40' 21" N, 100° 30' 14" W. The State of Texas installed the buoy barrier in this area for the purported purpose of deterring the passage of migrants who cross the border at this location in large numbers by swimming/walking across the river. The four-foot diameter buoys are anchored to the ground by concrete blocks. They also have webbing below them that prevents people from swimming under the buoys.

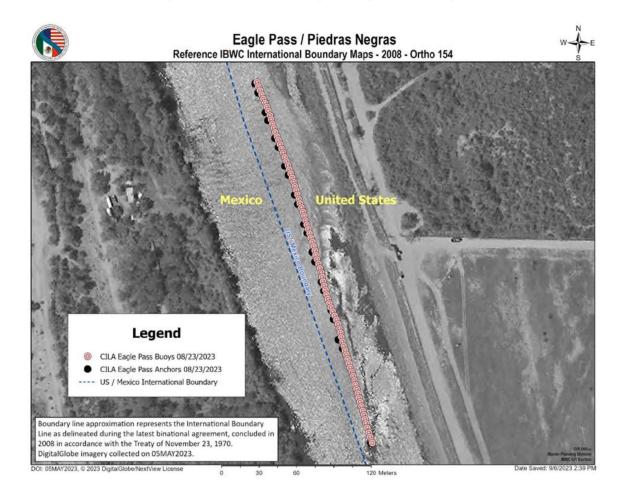
Exhibit 3: Survey Data Plot of the IBL and Eagle Pass Buoys (Mexican Section Survey of August 23, 2023)

The Mexican Section conducted another survey on August 23, 2023, to verify if this new buoy alignment encroaches into the territory of Mexico. The survey used a horizontal datum of World Geodetic System (WGS) 1984 Universal Transverse Mercator (UTM) Zone 14 N coordinate system. Results of the Mexican Section survey showed that the realigned buoys are now entirely within the U.S. side of the IBL (**Exhibit 3**).
